NBSIR 84-2929

Influence of Vertical Compressive Stress on Shear Resistance of Concrete Block Masonry Walls

Kyle Woodward
Frank Rankin

October 1984

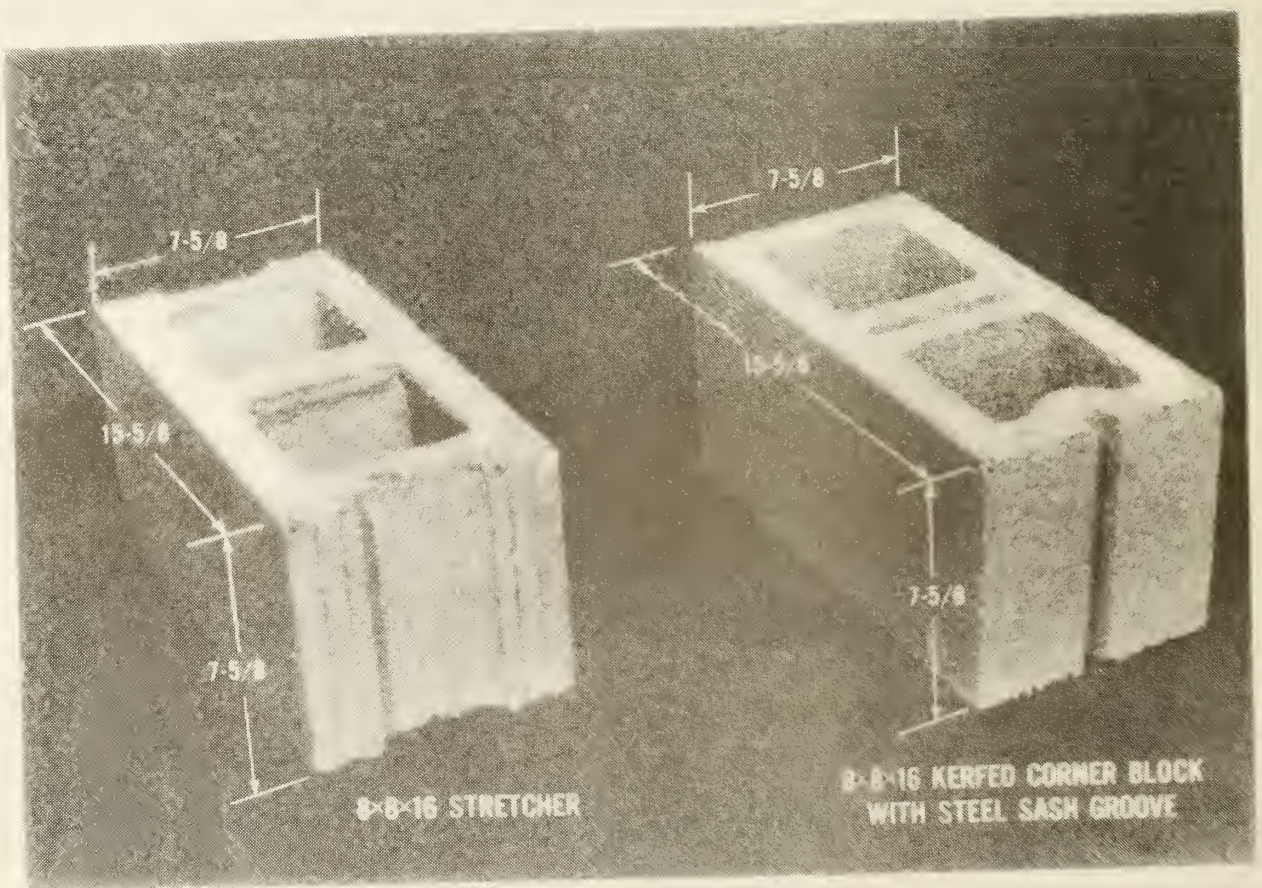
Figure 2.1 Concrete block units

1. 8 in. x 8 in. x 16 in., 2 core hollow strecher block.
2. 8 in. x 8 in. x 16 in., 2 core hollow kerfed corner block with a steel sash groove in one end.

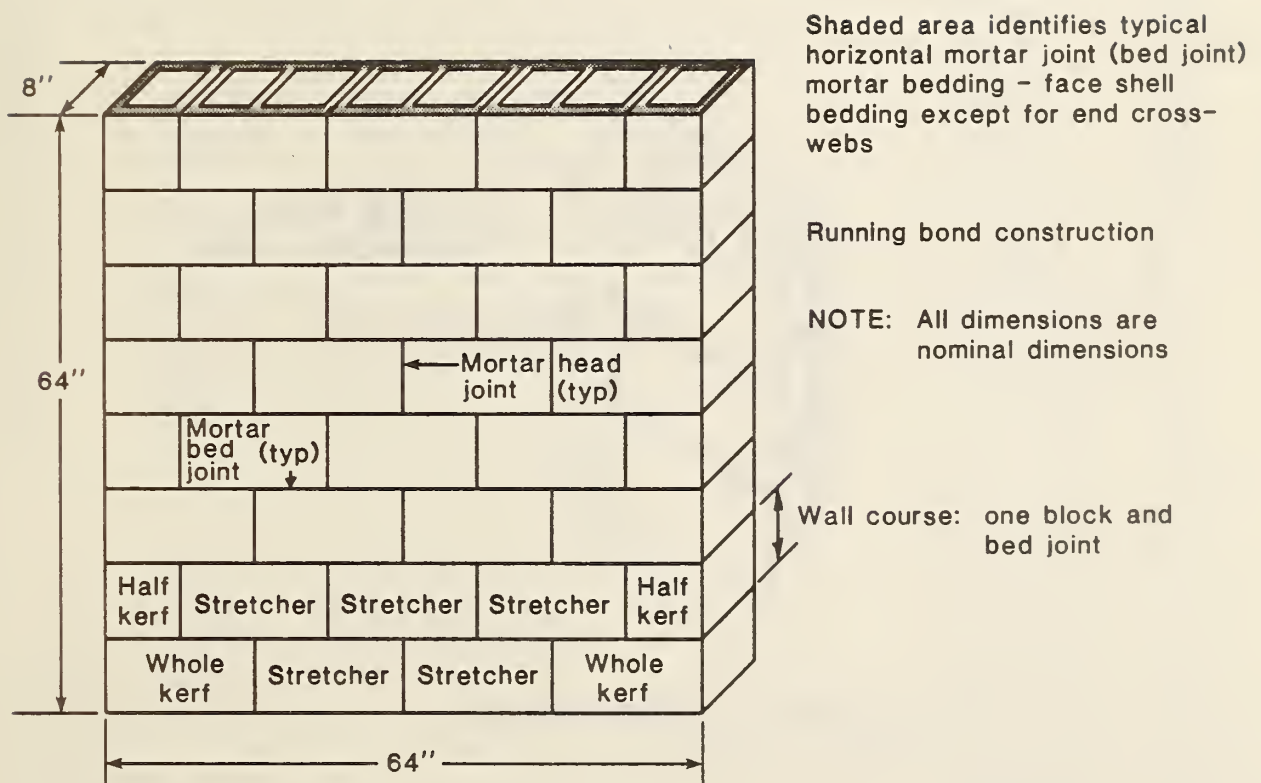
Figure 3.1 Typical wall panel

The wall panels were constructed in running bond with 50 percent overlap of block in alternate wall courses (fig. 3.1). The wall panels had overall nominal dimensions of 64 in. x 64 in. x 8 in. The wall panels (and prisms) were constructed by an experienced mason using techniques representative of good workmanship. The wall panels were fabricated in a controlled environment laboratory from materials stored in the same environment for at least 30 days. The temperature and relative humidity of the laboratory were maintained at approximately 73°F and 50 percent, respectively.

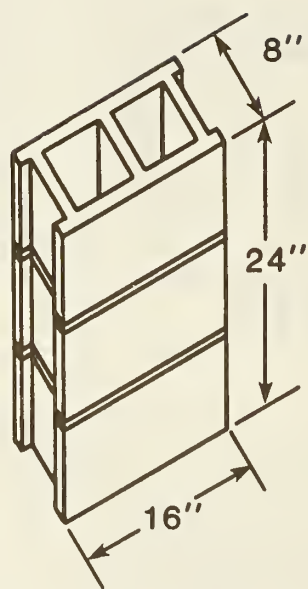
Figure 3.2 Typical prism

Three prisms were made along with each wall panel using mortar from the same batch as was used for the wall panel. Each prism was made by stack bonding three stretcher units (figure 3.2). The mortar bedding between the blocks was either face shell only or full area bedding. Within each group of three prisms the bedding was the same. The prisms constructed with seven walls had face shell bedding while the other prisms had full area bedding. The mason used a 4-foot level to maintain the level of each block and to plumb the prism.

3 unit high
stretcher units

CONCRETE BLOCK PRISM

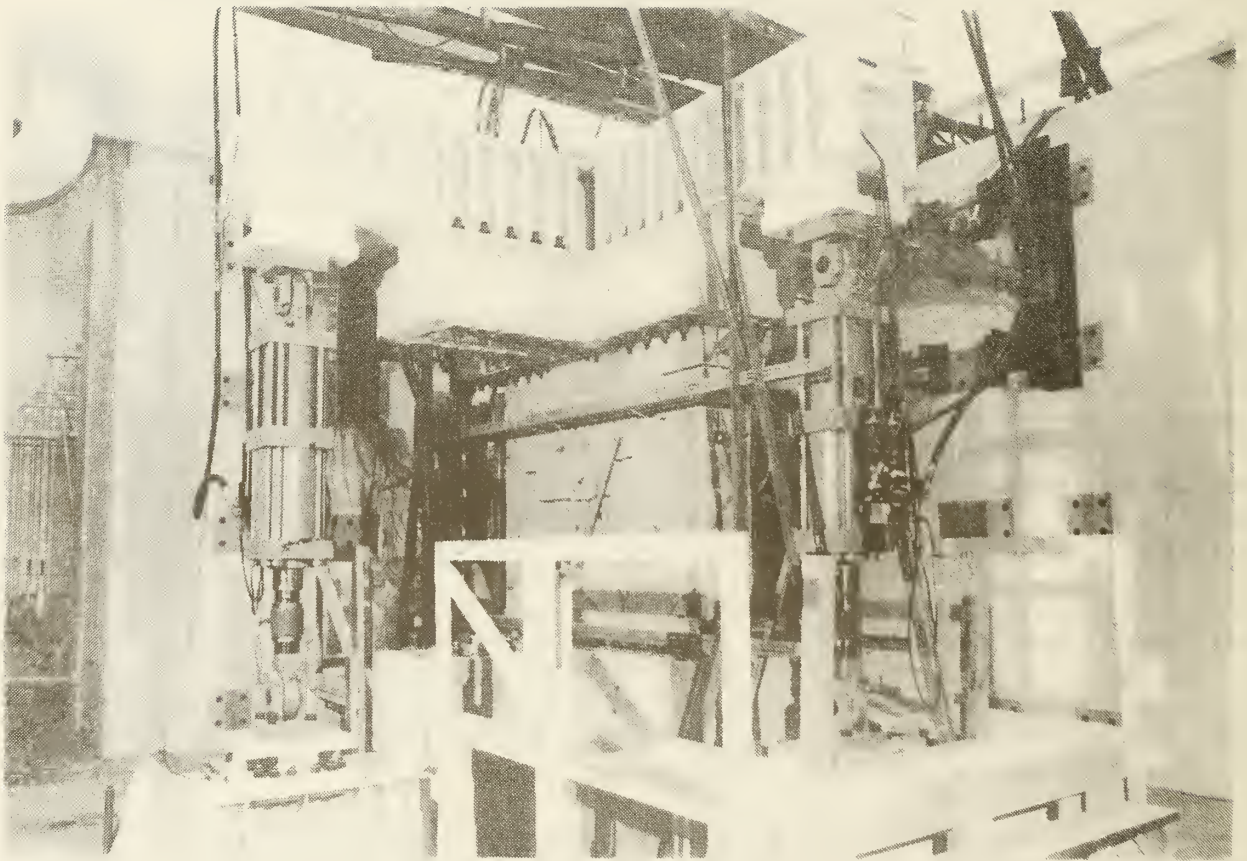
Figure 4.1 Test setup

The test setup (fig. 4.1) is the NBS Tri-directional Test Facility (NBS/TTF), a permanent loading apparatus designed to test building components using three-dimensional loading histories. The NBS/TTF is described in a separate report [9], but for purposes of completeness a brief summary is presented in this section.

The NBS/TTF is a computer-controlled loading apparatus which applies forces/displacements in all six degrees of freedom at one end of a test specimen. The other end of the specimen is fixed. The six degrees of freedom are the translations and rotations in and about three orthogonal axes. The application of such actions is accomplished by seven closed-loop, servo-controlled hydraulic actuators which receive their instructions by means of computer generated commands. The major components of the NBS/TTF are illustrated in fig. 4.1. The reaction system is composed of the structural tie-down floor and two vertical buttresses. The load distribution system consists of the two x-shaped steel crossheads, one at the bottom and the other at the top of the test specimen. The load application system is made up of the seven hydraulic actuators. The control system is not visible in the figure, but includes the servo-control electronics, the data acquisition equipment, and a minicomputer.

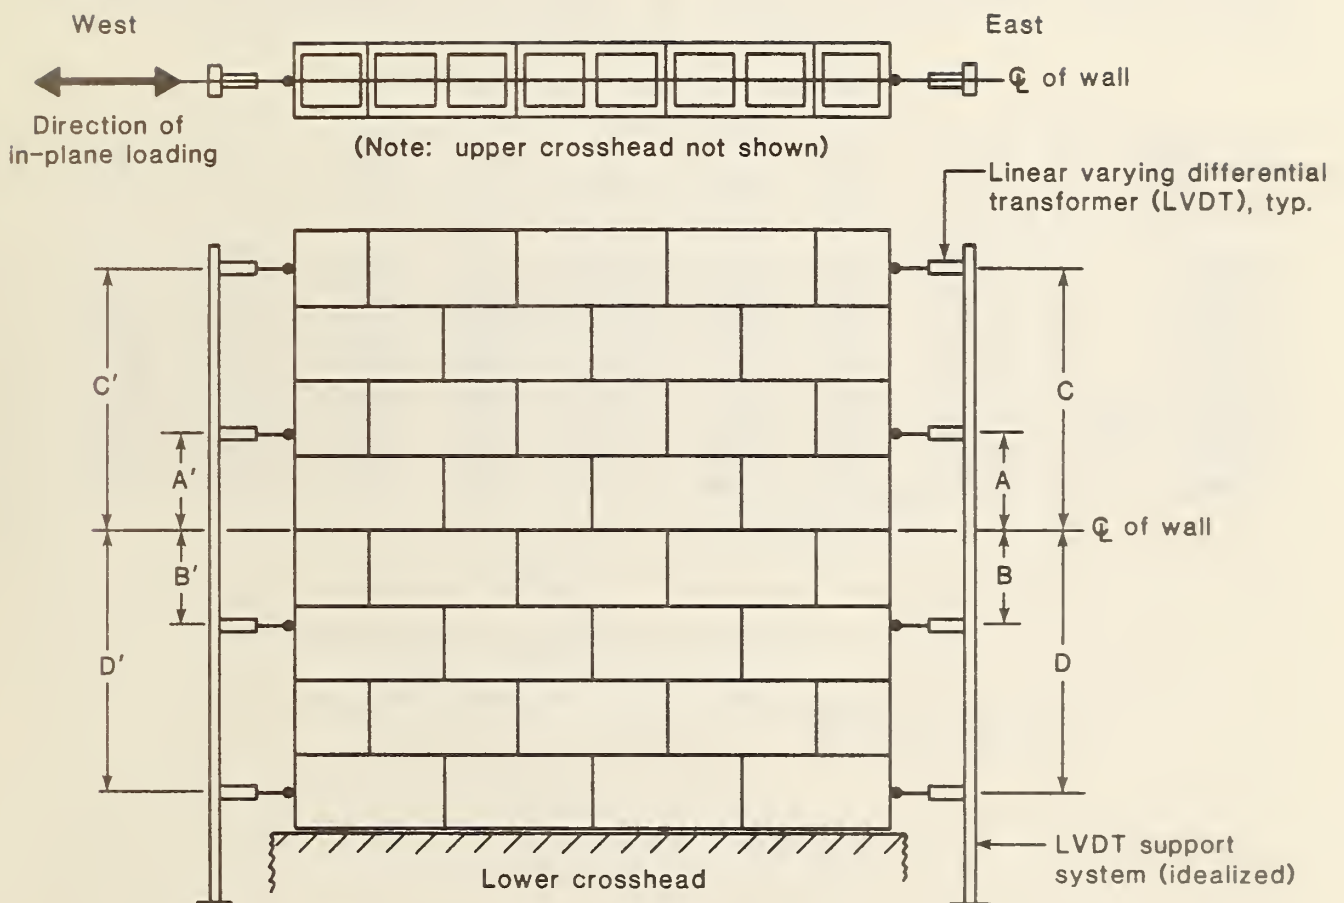
Figure 4.2 Wall panel LVDT layout

The in-plane displacement of a wall panel is measured by linear varying differential transformers (LVDTs) which are displacement transducers. The LVDTs are placed as shown in fig. 4.2 with four LVDTs located on each end surface of the wall. The actual positions of the LVDTs are listed in table 4.1. The LVDTs are mounted such that they measure the displacement of the wall relative to a fixed reference (tie-down floor).

Refer to fig. 4.2 for identification of dimension locations A,B,C,D,A',B',C', and D'.

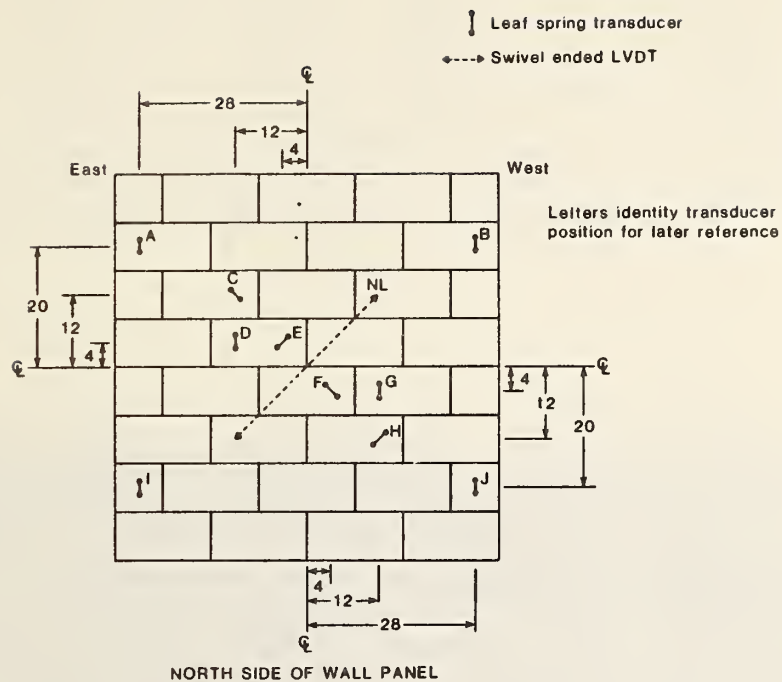
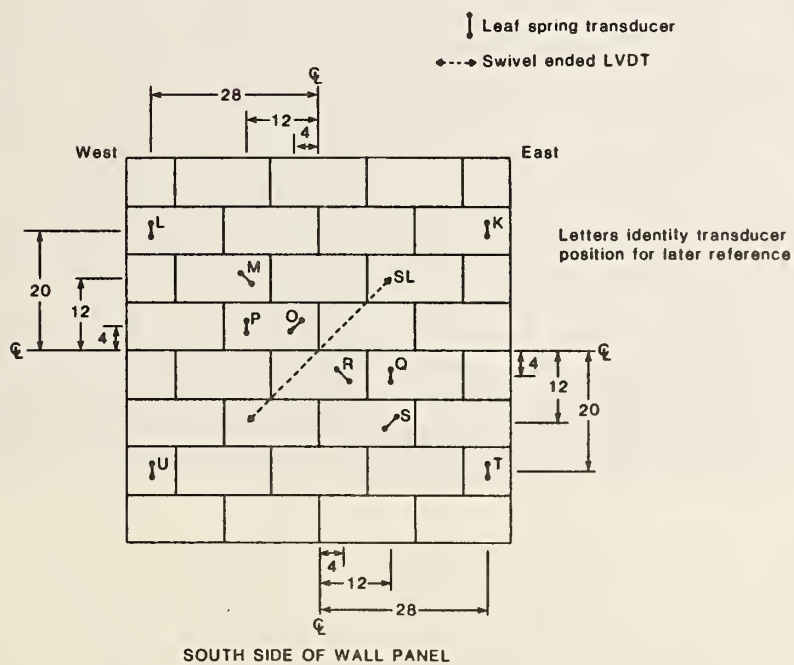
Figure 4.3 Wall panel instrumentation

In addition to the overall measurement of the wall displacement, local measurements of displacement are made on each of the wall panel face shells. These displacement measurements are taken between points on the wall and not referenced to a fixed position. The local displacement measurements are made at the locations shown in fig. 4.3 using specified gage lengths so that strain can be computed. The displacement over the two long gage lengths is measured by LVDTs mounted on swivels between two posts glued to the wall surface (fig. 4.4). The displacement over the short gage lengths is measured by specially

Numerous strain measurements are available for each wall panel test. The strain measurements are from a variety of locations on each wall panel (fig. 4.3). For this report the data from only one of the locations is presented. The strain measured by an LVDT mounted parallel to the diagonals provide an excellent general indication of overall wall diagonal strain. Since the cracking appears to form as a result of diagonal tension the displacement measured by the north side LVDT (denoted as NL in fig. 4.3) provides a measure of the diagonal tensile strain in the wall. The local displacements measured by the diagonally mounted wall LVDTs are divided by the initial gage length to arrive at a strain value. The gage length used in all computations for the diagonally mounted LVDT strain is 33.941 in. which is the diagonal length of a 24 in. square (fig. 4.3).

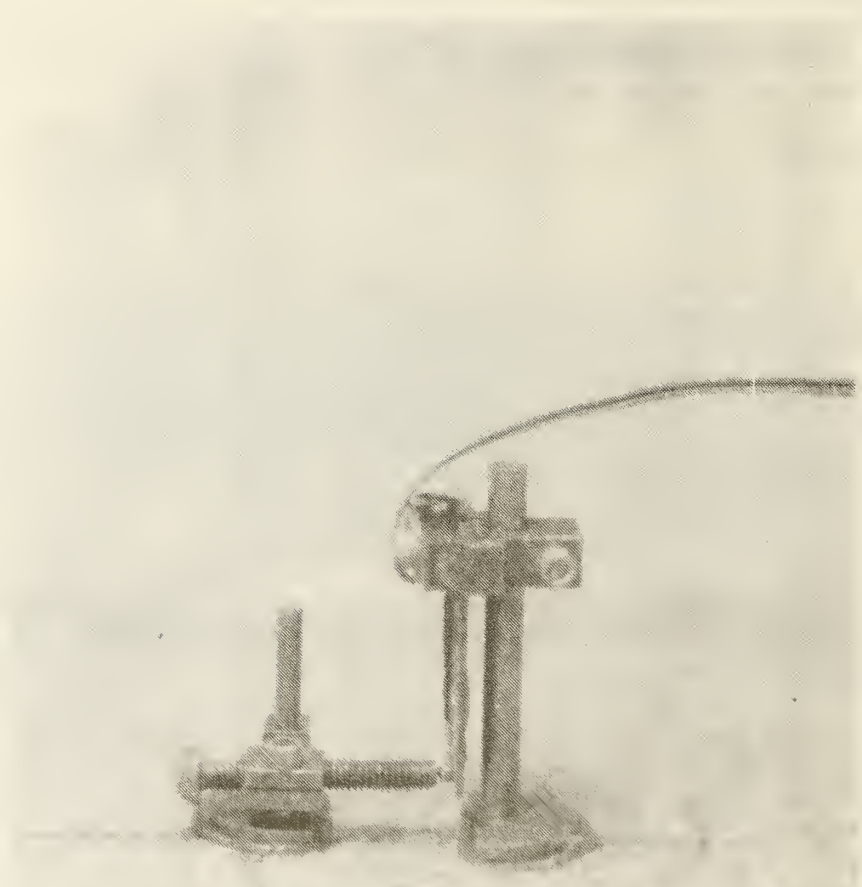
Figure 4.5 Leaf spring transducer

designed leaf spring transducers (LSTs) (fig. 4.5). The LSTs are strips of metal (titanium) with strain gages mounted on each side (temperature compensated) such that the output signal from the strain gages is proportional to the tip displacement of the leaf spring. Each LST is calibrated to determine the relationship between leaf spring tip displacement and the strain gage output. A typical estimate of standard error for the regression analysis of displacement versus LST output is 15 microinches. The LSTs are mounted on posts glued to the wall (fig. 4.5) with a gage length of 1 in. The LSTs are mounted only on block units and their gage lengths do not cross mortar joints.

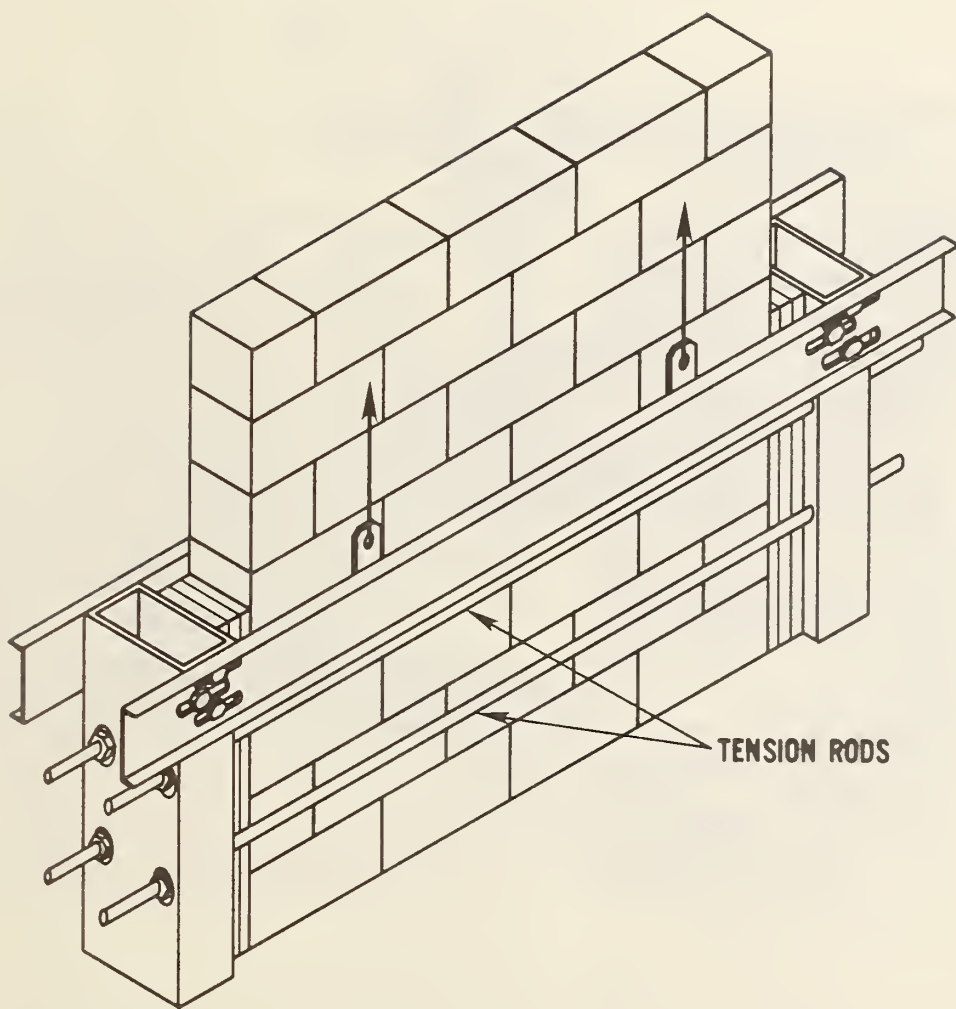
Figure 4.6 Wall panel transport harness

Each of the wall panels was handled by attaching a carrying harness to the panel (fig. 4.6). The harness had attachment points for lifting the wall and a clamping arrangement which held the harness against the ends of the panel. An overhead crane and specially fabricated device was used to place the wall panel in the NBS/TTF. The special device was a large welded assembly in the shape of a "C" (fig. 4.7). The shape permitted the crane hook to be centered above the wall panel without interfering with the upper crosshead during placement (fig. 4.8).

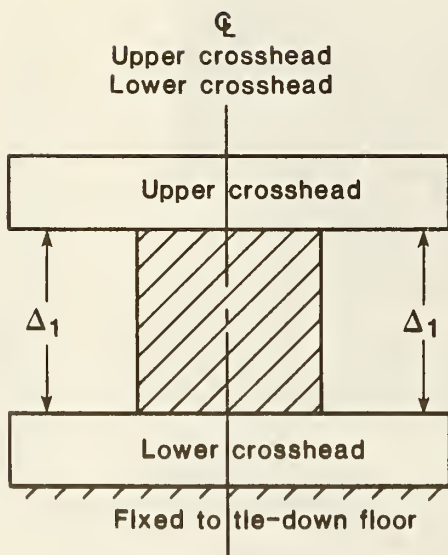
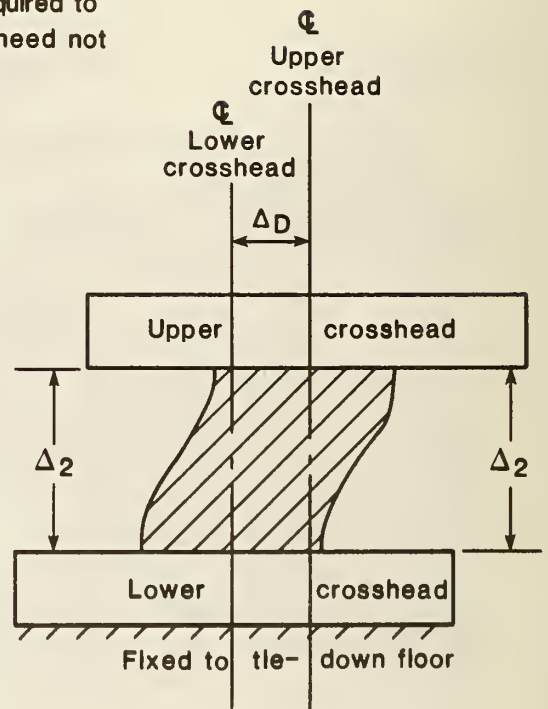
Figure 4.9 In-plane displacement method

Δ_D is the imposed in-plane lateral displacement

Δ_1, Δ_2 are the vertical dimensions required to achieve desired vertical load. Δ_1 need not equal Δ_2 .

SIMPLIFIED DESCRIPTION OF IMPOSED DISPLACEMENT

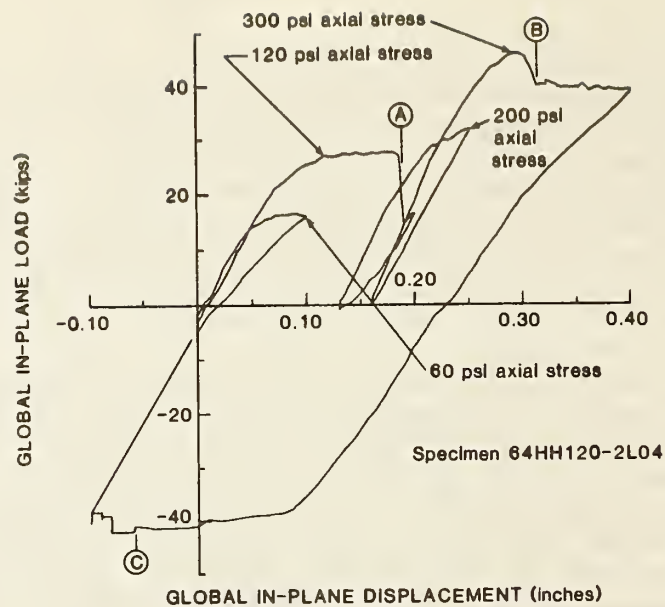
Figure 5.1 Specimen 64HH120-2L04 load-displacement curve

The loading history of this wall included displacements with several different compressive axial stress levels (fig. 5.1). The purpose of this test was to find the minimum level of compressive axial stress required to produce a "shear" failure (diagonal cracking) rather than a "flexure" failure (horizontal cracking). The initial axial stress of 60 psi did not suppress the flexural mode as shown by the crack pattern (fig. 5.2) which exhibited a pronounced horizontal flexure crack at the first course mortar joint. The lateral displacement was returned to zero and the axial stress was increased to 120 psi. The lateral displacement was then increased until the bottom west block developed a diagonal crack extending from the previous flexure crack in the mortar joint to the bottom corner of the block. The displacement was denoted by the symbol A in fig. 5.1. The decrease in lateral load resistance coinciding with the formation of the block diagonal crack was very pronounced. At this point in the test it was decided to increase the axial stress and repeat the lateral movement until a complete wall diagonal crack could be formed. The lateral displacement was decreased until the lateral force was approximately zero. The axial stress was increased to 200 psi and the lateral displacement was then increased. It appeared that the cracking was confined to the existing cracks so the axial stress was increased again. The previous steps were repeated except that the axial stress was increased to 300 psi. A complete wall diagonal crack occurred at this axial stress level with an accompanying reduction in lateral load resistance. The wall diagonal crack passed mostly through the blocks rather than the mortar joints. The displacement was denoted by symbol B in fig. 5.1. The displacement was then reversed until a diagonal crack formed along the other diagonal. The displacement at which this occurred was denoted by symbol C in fig. 5.1.

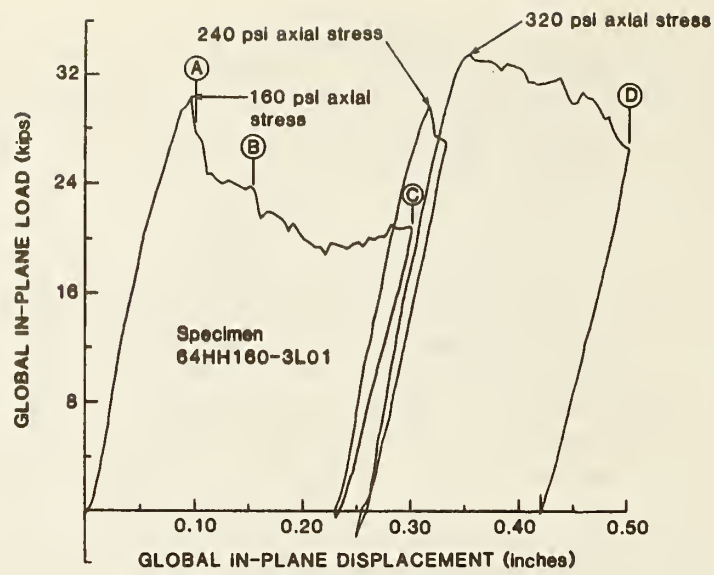
Figure 5.3 Specimen 64HH160-3L01 load-displacement curve

The compressive axial stress was initially set at 160 psi. The lateral displacement was eventually increased to a displacement equal to about three times that at which diagonal cracking actually occurred in the wall (fig. 5.3). The diagonal cracking which occurred with the 160 psi axial stress was primarily confined to the mortar joints in a stair-step fashion (fig. 5.4). The axial stress was subsequently increased to observe the effect, if any, of increasing the axial stress after cracking had occurred. As seen in the load-displacement curve the maximum lateral load resistance for higher axial stress was significantly greater than the resistance observed at the same displacement for lower axial stresses, but the overall maximums were not significantly different. For example, the maximum lateral load resistance observed for the case of 240 psi axial stress was approximately 30 kips and occurred at a displacement of about 0.31 in. The resistance observed at about the same displacement for the case of 160 psi axial stress was 21 kips. However, the maximum lateral load resistance for the case of 160 psi axial stress was 30 kips. Thus, the maximum load resistance was about the same regardless of axial stress when the wall was already cracked before increasing axial stress. The limiting resistance seemed to involve that associated with slippage along the crack since relatively few new cracks formed, but crushing zones were observed along certain portions of the primary diagonal crack. Lateral load resistance was stable within the lateral displacement imposed on the wall at the higher compressive axial stress.

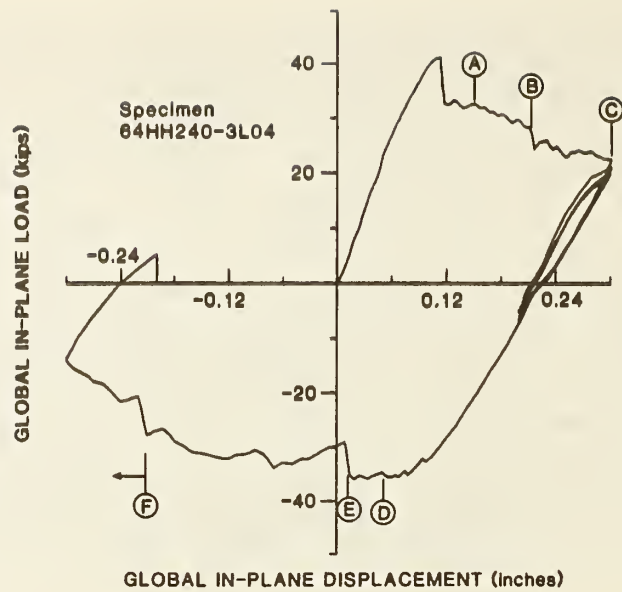
Figure 5.5 Specimen 64HH240-3L04 load-displacement curve

The compressive axial stress was maintained at 240 psi throughout the test. The diagonal cracking began in the center portion of the wall diagonal and extended to each corner. A sharp drop in lateral load resistance (fig. 5.5) occurred as the diagonal crack reached its full length. The diagonal crack passed through both block units and mortar joints (fig. 5.6). As the displacement was increased past the displacement at which diagonal cracking first occurred the lateral resistance decreased slowly. However, a point in the loading history was reached (denoted by the symbol B in fig. 5.5) where two loud bangs were heard from the wall and the resistance decreased at a higher rate. No new cracks were observed to form with the noises and based on later examination of the wall it was suggested that the noises were caused by the splitting of cross-webs in the compression zones of the wall. The displacement was cycled several times with a small displacement amplitude near the extreme displacement limit to observe the rate of degradation of resistance with non-reversed cycling. The displacement was then fully reversed until a diagonal crack formed along the other diagonal of the wall panel. The final failure was primarily crushing along the diagonal crack in the lower west corner compression zone.

The effect of displacement reversals is observed in walls 64HH240 and 64HH320. The load-displacement curve for wall 64HH240 shown in fig. 5.5 suggests that for partial reversals of displacements such as a half-cycle pattern the effect of reversals on stiffness and lateral load resistance is small. However, the load-deflection curve for wall 64HH320 (fig. 5.9) indicates that the effect of complete displacement reversals is significant with large reductions in stiffness and lateral load resistance.

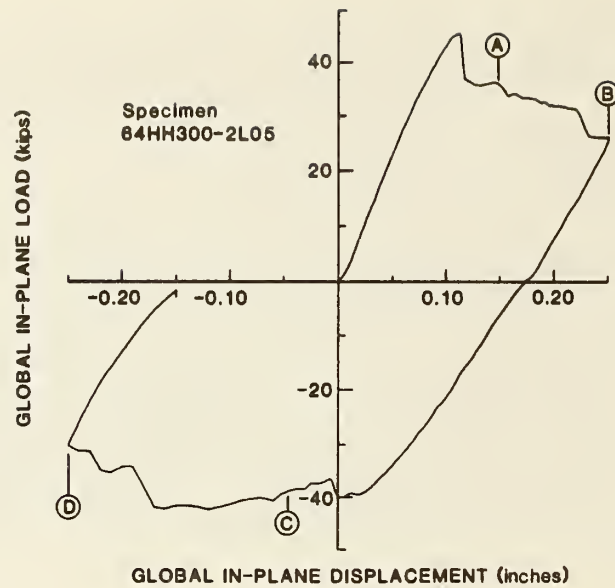
Figure 5.7 Specimen 64HH300-2L05 load-displacement curve

The compressive axial stress was maintained at 300 psi throughout the test. The loading history was basically one cycle with fully reversed displacements (fig. 5.7). The diagonal crack which formed during the initial lateral displacement of the wall panel initiated in the central region of the wall and extended along the diagonal to the opposite corners (fig. 5.8). The cracking occurred primarily through the block units and not the mortar joints. The small flexure crack which was observed in the lower east bed joint occurred at a displacement very near the occurrence of diagonal cracking. As the displacement was increased past the displacement at which the first full diagonal crack formed the lateral resistance was initially stable (remained constant) but, with increasing displacement, a parallel diagonal crack formed and the resistance decreased. The displacement was increased until noticeable crushing occurred in the lower west corner of the wall. As the crushing occurred the lateral resistance decreased sharply. The displacement was then fully reversed. Diagonal cracks formed along the other diagonal, but this time the diagonal cracking passed through both block units and mortar joints. The angle of the crack was also different.

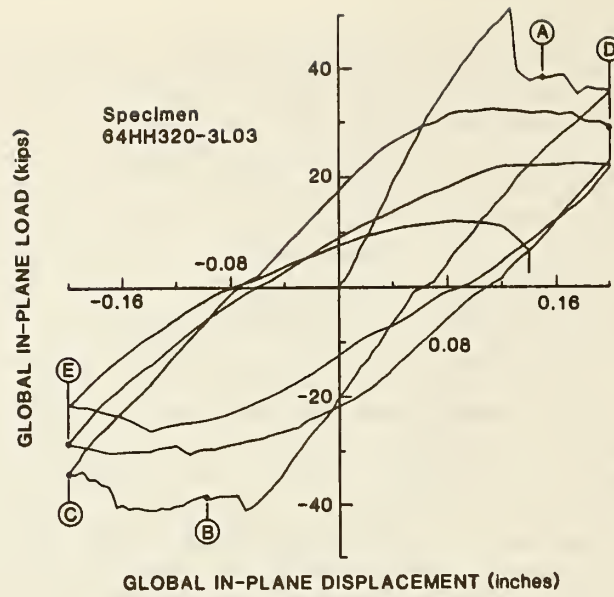
Figure 5.9 Specimen 64HH320-3L03 load-displacement curve

A compressive axial stress of 320 psi was maintained on the wall panel throughout the lateral displacement. The wall was first displaced 0.2 in. to the west (fig. 5.9). The diagonal crack which formed (fig. 5.10) during this displacement was accompanied by a loud bang and a sudden drop in lateral load resistance. Displacement of the wall between the displacement at first cracking and 0.2 in. produced several more loud bangs, but no new visible cracking. The load resistance decreased with increasing displacements. The displacement was fully reversed and then cycled three times between the two reversed displacement limits. The first reversal to 0.2 in. (denoted by symbol C in fig. 5.9) in the east direction caused two diagonal cracks to form, one after the other. The first crack did not extend to the two corners (lower east and upper west), but the second crack included extensions to the corners. The second cycle to 0.2 in. to the west (denoted by symbol D in fig. 5.9) produced a vertical crack along the face shells of the west end with an accompanying large reduction in lateral load resistance. The second cycle to 0.2 in. to the east (denoted by symbol E in fig. 5.9) produced vertical cracking on the east side, but no drop in resistance was observed. The third cycle produced some reduction in resistance and stiffness, but no new cracks were visible. The attempt at a fourth cycle was terminated when the wall panel could not sustain the 320 psi axial stress and crushing occurred.

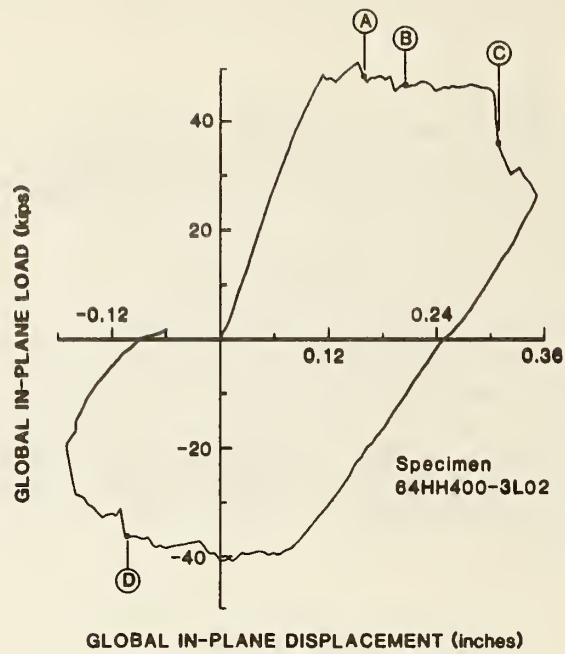
Figure 5.11 Specimen 64HH400-3L02 load-displacement curve

The compressive axial stress was maintained at 400 psi. The loading history was basically one cycle between reversed displacement limits (fig. 5.11), but the displacement limits were unequal. The first diagonal crack due to displacement in the west direction occurred at 0.125 in (fig. 5.12). The cracking initiated in the central region of the wall and then propagated along a line below the true wall diagonal. A second diagonal crack formed at 0.175 in. which propagated along and above the true wall diagonal. The lateral load resistance was essentially constant during the formations of both cracks. The lateral load resistance remained constant until a displacement of about 0.3 in. was reached at which point a loud bang was heard followed by extensions of the previous cracks and a sudden decrease in lateral load resistance. During the reversal of displacement diagonal cracks formed along the other diagonal, but the test was terminated when the wall could no longer sustain the 400 kip axial stress.

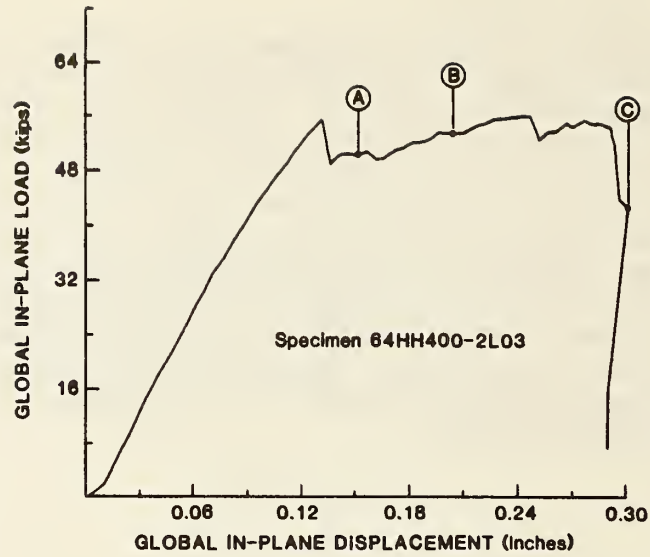
Figure 5.13 Specimen 64HH400-2L03 load-displacement curve

A compressive axial stress of 400 psi was maintained on the wall. This test was a monotonic test to failure (fig. 5.13). The final failure was an inability to sustain the 400 psi axial stress. The first diagonal crack to form included the upper east corner, but did not extend to the lower west corner (fig. 5.14). The crack was visible only after the lateral load resistance dropped. Just prior to the drop in resistance a loud bang was heard. The second, roughly parallel, crack included the lower west corner. The second crack occurred only after a significant increase in displacement past the displacement coinciding with the formation of the first crack. The lateral load resistance increased as the displacement was increased until a displacement was reached where a complete diagonal crack formed. Increasing the displacement further led to a zone of crushing in the lower west corner followed by a sudden loss in vertical load (stress) resistance.

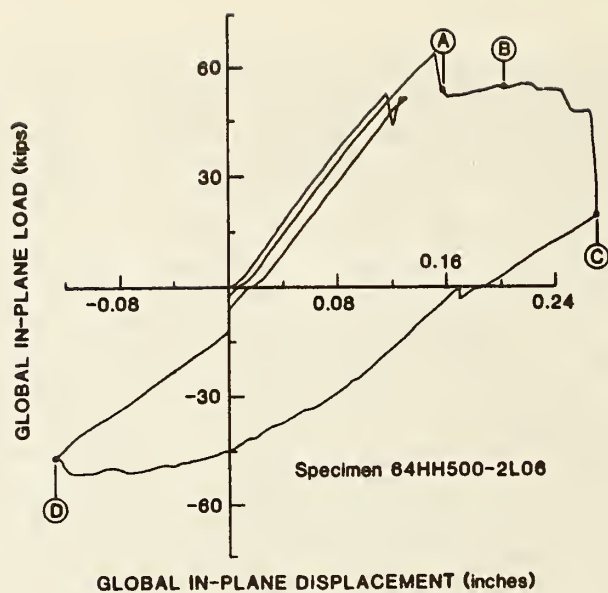
Figure 5.15 Specimen 64HH500-2L06 load-displacement curve

The axial stress was maintained at 500 psi during most of the test. The loading history was basically a single cycle, reversed displacement pattern (fig. 5.15), but an unexpected problem modified the loading history. The first attempt at applying a lateral displacement was terminated by the control software because preset load limits were exceeded. Preset load limits restrict the range of loads which can be applied to the specimen as a precaution against unintentional overloading of the specimen. The axial stress was reduced and the lateral displacement returned to zero. The preset load limits were increased so that the error indication would not occur and the axial stress was again increased to 500 psi. The lateral displacement was then applied with no further difficulties. The initial diagonal cracking occurred in the center region of the wall (fig. 5.16) accompanied by a reduction in lateral load resistance. With increasing displacement, the crack propagated to the corners and a second crack formed roughly parallel to the first crack. A displacement level was reached, however, which resulted in crushing of certain regions of the wall followed by a sharp drop in lateral load resistance and the inability of the wall to sustain the 500 psi axial stress (denoted by symbol C in fig. 5.15). The axial stress was reduced and the displacement reversed until zero lateral load was achieved. The axial stress was then increased to 500 psi and the displacement increased in the opposite or east direction. Diagonal cracking occurred in the opposite direction, but the cracks were not continuous. The test was terminated because the vertical displacement required to maintain the vertical 500 psi stress was considered excessive.

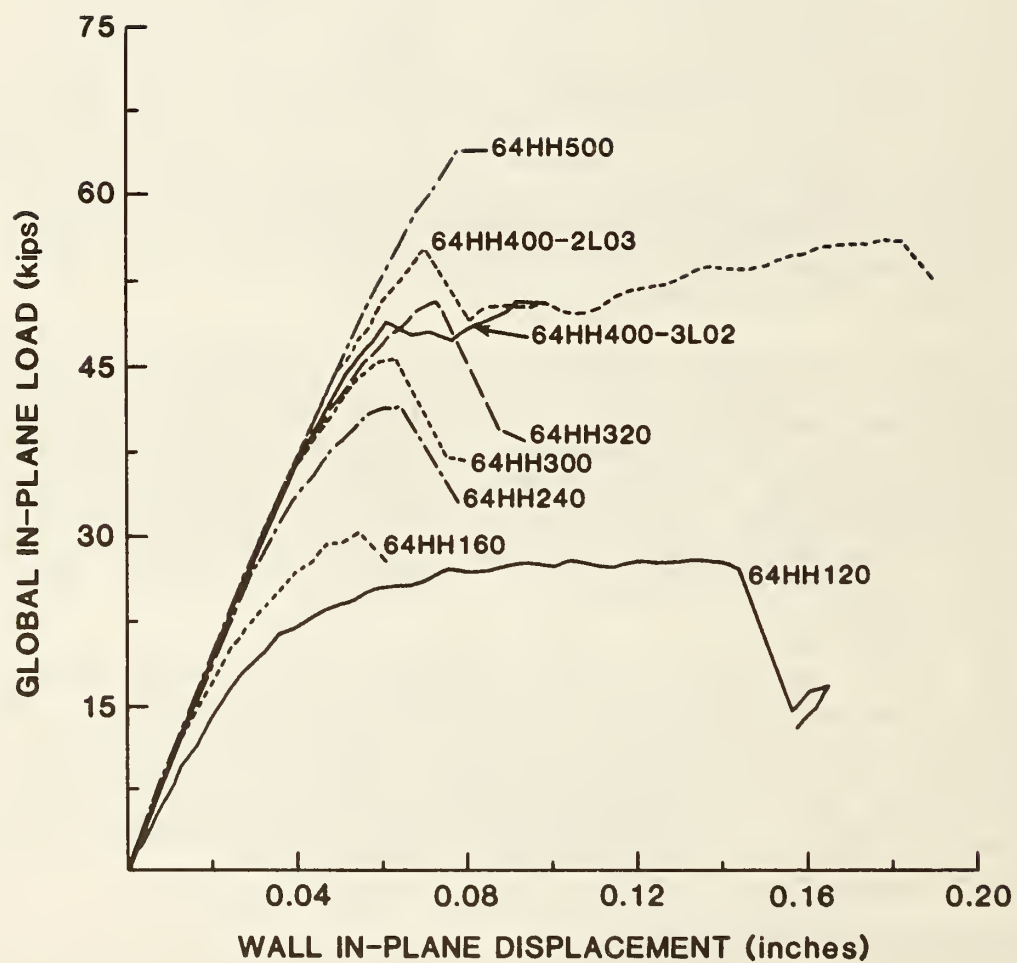
Figure 6.1. Combined load-displacement curves

The load-displacement curves for all eight wall panels are shown in fig. 6.1. The load is the in-plane global lateral load and the displacement is the movement of the wall at the top course of the wall as measured by the top west LVDT (fig. 4.2). The curves are only shown to a point slightly beyond achieving the peak lateral load resistance. The curves for 64HH120 and 64HH500 have been adjusted to eliminate their initial loading cycles. It is clear that

wall 64HH120 is heavily influenced by flexure which accounts for the general rounding of the curve and the large displacement required to achieve diagonal-tension failure. The wall 64HH160 demonstrates much less influence of flexure, with only a small increase in maximum lateral load resistance. The remaining walls show the same general trend, less rounding of the curve and a sudden drop in lateral load resistance. The wall 64HH400 - 3L02 is an interesting anomaly in that its behavior is not like its companion 64HH400 - 2L03. At present, it is not known why 64HH400 - 3L02 exhibited such behavior.

In fig. 6.2, the computed strains from the north LVDT measurements are plotted versus the same wall displacement used in fig. 6.1. The strain-displacement curves exhibit a definite breakpoint at which the curves become asymptotic with large increases in strain for small increases in displacement. This is, of course, indicative of the formation of physical cracks in the wall. The curve for 64HH120 is an exception to the general trend, but it may be discounted since the wall is strongly influenced by flexure rather than by shear as is the case

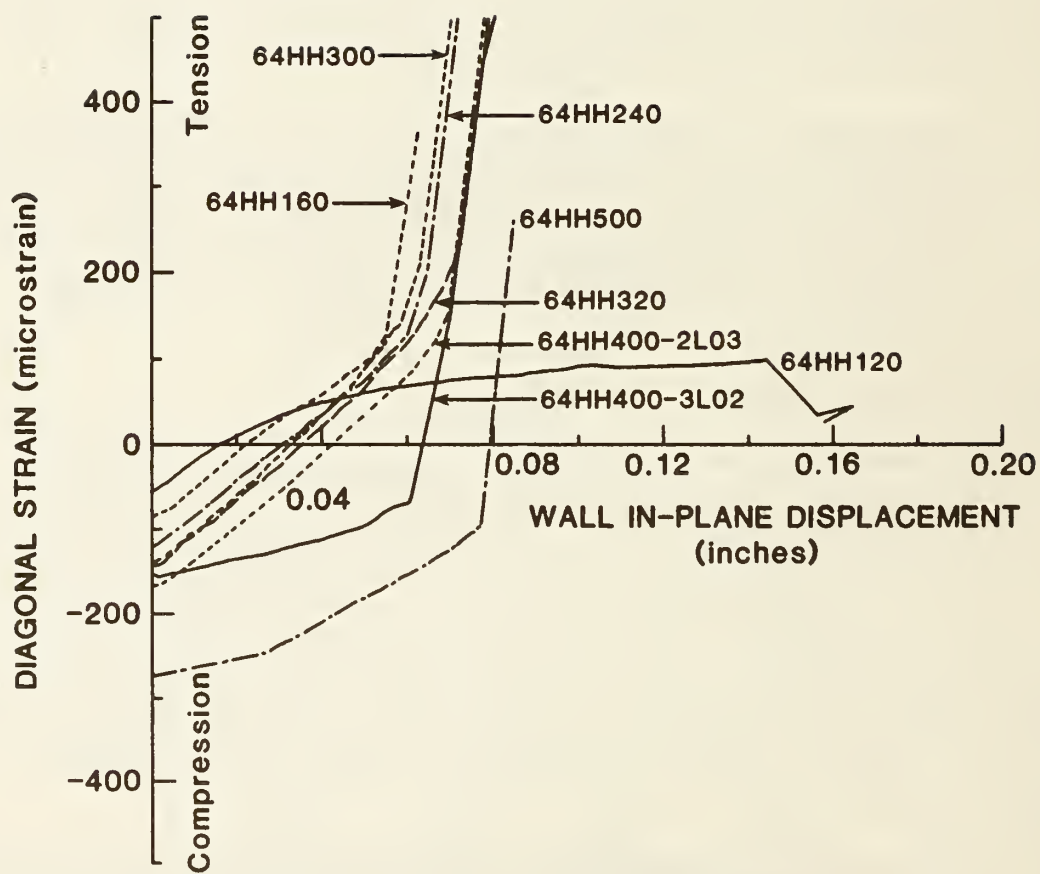
Figure 6.2. Combined diagonal strain-displacement curves

in the other walls. More interestingly, however, is that for the walls having moderate amounts of axial stress (160-320 psi) the strain at which the strain-displacement relation changes is approximately the same for all the walls and has a value of about 150 microstrain. This common value certainly suggests that the limiting criterion for the formation of diagonal cracking and consequently maximum lateral load resistance is determined by a critical tensile strain. The critical or threshold value of strain is more clearly shown in fig. 6.3 which is a plot of global in-plane load versus the same strain as in fig. 6.2. The wall panels 64HH400-3L02 and 64HH500 are exceptions to the common threshold tensile strain of 150 microstrain, but the two walls do exhibit a similar strain threshold. That fact may eventually provide a clue as to why they behave differently, but the information currently available does not provide an answer.

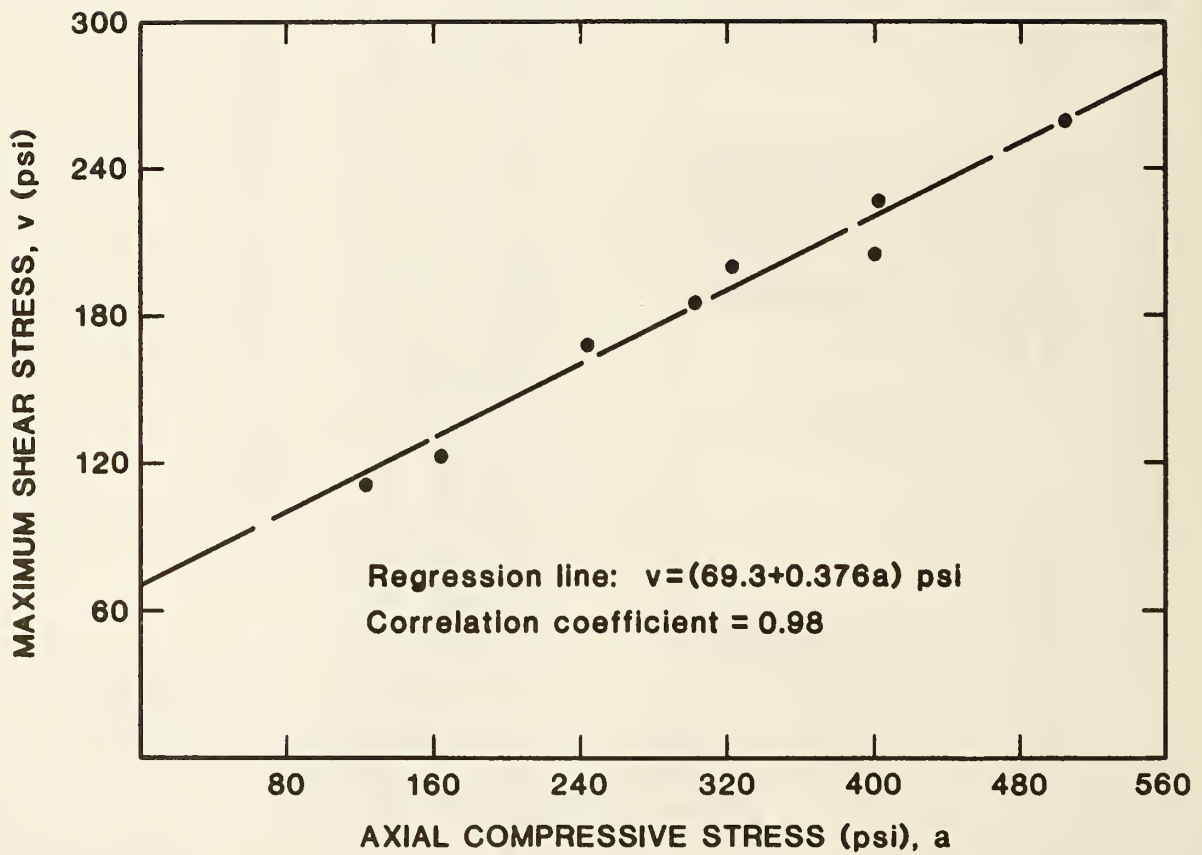
Figure 6.4. Maximum shear resistance versus axial stress

Typically, the single most important aspect of behavior to a designer is the maximum resistance. As a result, the factors which influence the maximum resistance need to be accounted for in design. Based on eight wall panel tests the influence of axial compressive stress on the diagonal-tension capacity of a wall follows a definite trend. A list of the maximum lateral load resistances for the wall panels is presented in table 6.1. Clearly, for changes in axial compressive stress between 120 and 500 psi, increasing the axial stress increases the maximum lateral load resistance. The trend of the relationship is shown in fig. 6.4 which is a plot of maximum shear stress versus the axial compressive stress. The maximum shear stress is computed by dividing the maximum lateral load resistance by the net cross sectional area of the wall (246 sq. in.). The axial stress is the total axial load divided the same net cross sectional area of the wall. The relationship is strongly linear as evidenced by the "best-fit" line developed by a linear regression analysis and its resulting correlation coefficient (0.98).
